All Saints Church, 564 Woodham Lane, Woking, GU21 5SH Sanctuary Floor Completion Report October 2024

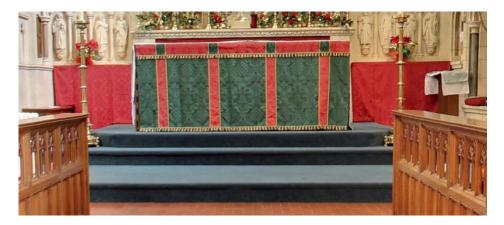
Things took a turn for the worse when, on 25 July 1991 a Faculty was granted for: "The removal of the existing top step in the Sanctuary of the Parish Church of All Saints; modifications to remaining steps; and carpeting of the area." The top step was removed, the marble of that step was thrown away and the space was infilled with a concrete screed. Wooden plinths were added drilled into the marble to extend the remaining steps. The area was then carpeted:

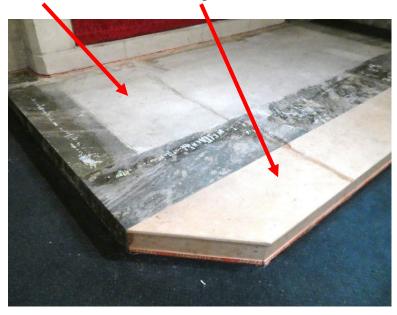
It revealed the concrete screed and the wooden plinths:

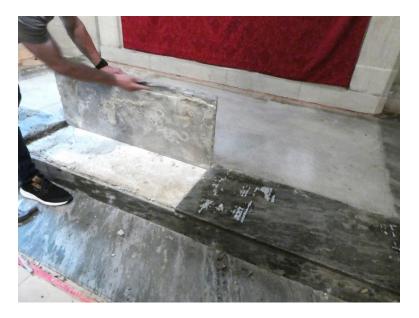
Most of the marble was loose:

Liviu Negut of Calacatta Stone & Ceramics repaired and re-set the repairable marble, and laid the new marble. He also restored the curve of a crumbled pillar:

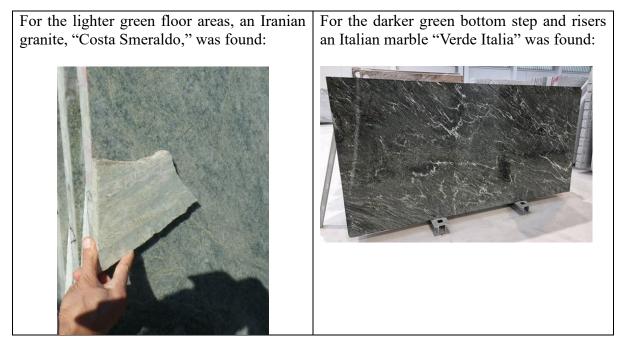
New marble was needed for the top step to replace the concrete screed and for other marble that was beyond repair. Swedish marble is no longer available.

The slabs were 30mm thick, which was the depth needed for the steps, but the risers and floor areas needed to be milled down to 20mm thick. The milling and cutting were done by the Marble & Granite Cutting Centre Ltd, Slough <u>https://mgcc-ltd.co.uk/</u>
